# BULLETIN

### BEACH EROSION BOARD

APRIL 1, 1949

#### SAND MOVEMENT STUDY AT LONG BRANCH, N.J.

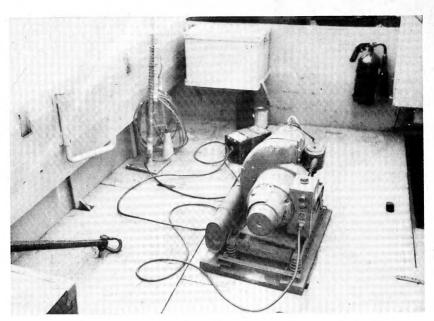
CARGO DECK OF "DUCK" SHOWING GENERATOR, TRANSFORMER, AND LIGHT MOUNTING

This equipment consisted of a 220 volt, 60 cycle, 1600 lumen mercury vapor lamp with a 400 volt-ampere, 110-220 volt autotransformer. A  $1\frac{1}{2}$  kilovolt-ampere generator, driven by a gasoline engine, was provided as the source of power for the lamp. The sounding craft on which the installation was made was an Army  $2\frac{1}{2}$ -ton amphibian truck (commonly known as a "Duck"). Accompanying photographs show the location of this equipment aboard the "Duck." Reasonable protection, such as a canvas tarpaulin, had to be provided for the transformer and generator to shield it from salt water spray. The lamp itself required no additional protection as it is constructed of two concentric pyrex tubes, the outer tube protecting the hot inner tube from breaking due to contact with sea spray.

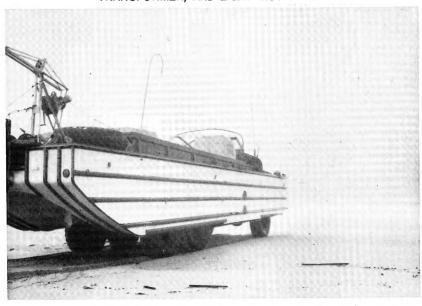
MERCURY VAPOR LAMP INSTALLED ON "DUCK"

When the apparatus was installed, a number of tests were made which showed that the use of the lamp increased the range of working visibility by fifty to seventy-five percent. The Field Research Group of the Beach Erosion Board has used the equipment during hydrographic survey operations extending over a period of several months, and during this period it is estimated that time lost due to haze and fog has been reduced by fifty percent.
